HISTORY OF GEAR FAILURES IN A STEAM TURBINE DRIVEN INTEGRALLY GEARED COMPRESSOR

MATTHEW BARAUSKY & PATRICK SMITH

42nd Turbomachinery
29th Pump SYMPOSIA

AIR
PRODUCTS

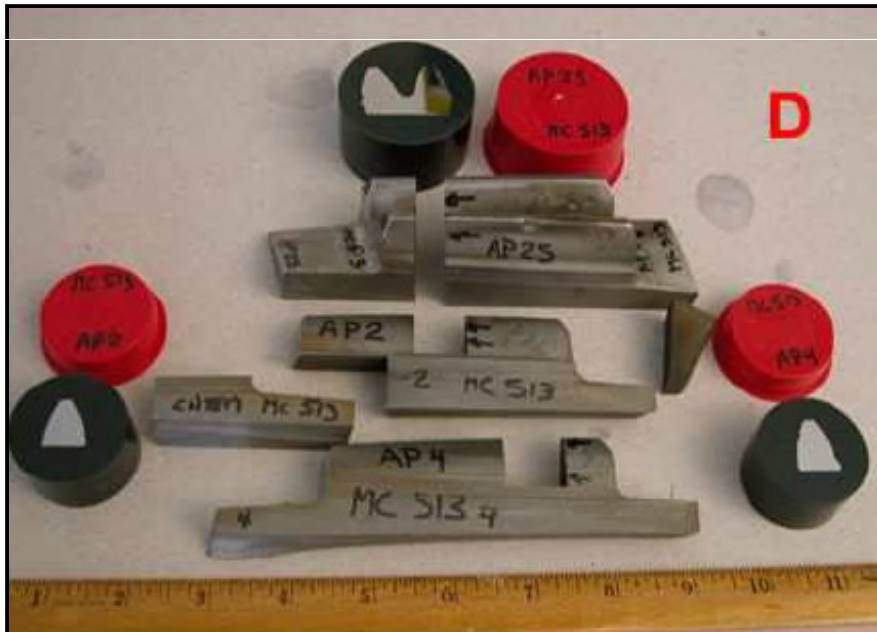
#1 Pinion Failure Analysis

- Visual, metallurgical, and engineering analyses indicated that there were (3) possible root causes:
 1. Hydrogen contamination
 2. Overload
 3. Lubricant failure

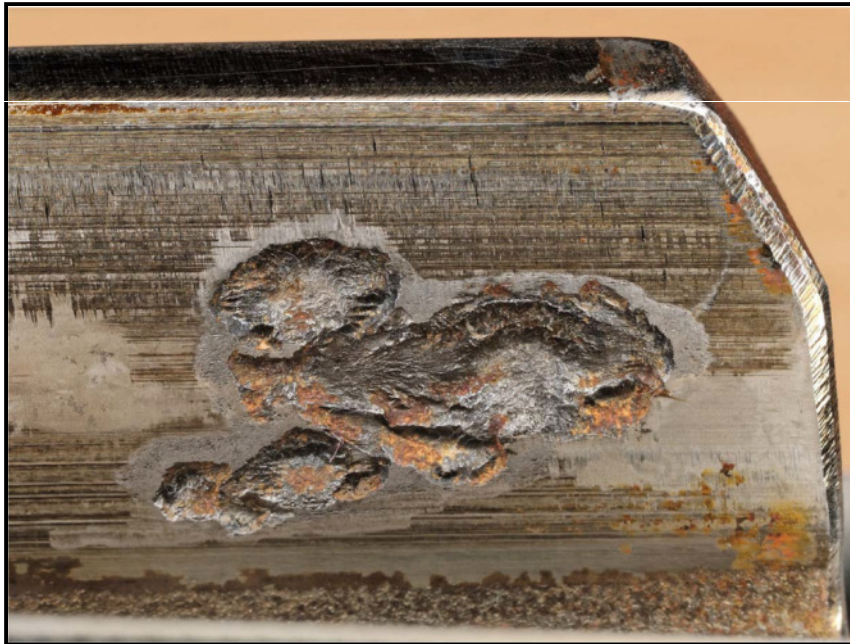
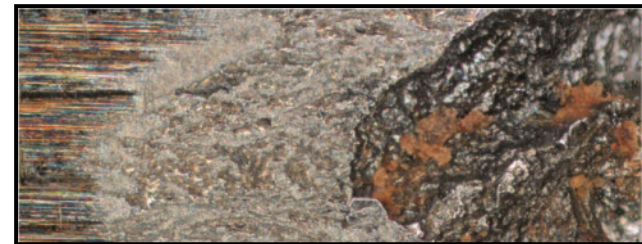
#1 Pinion - Overload

- Gears specified to AGMA or DIN 3990 standards with appropriate pitting resistance and bending strength service factors.
- API-613 not required but used as a reference during investigation.
